Giving a second life to an old refurbished centrifugal compressor

Case studies show end users should be aware of refurbishing opportunities.

By **Andrea Fusi, Andrea Betti and Emanuele Burberi** of C.S.T. Compression

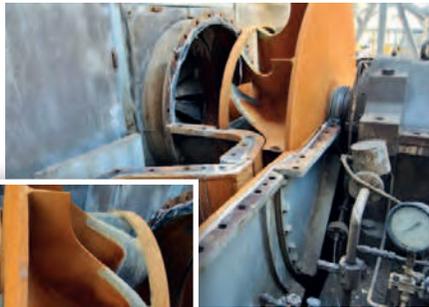
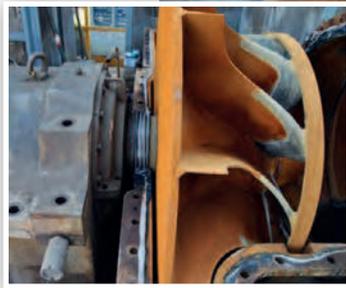
FIGURE 1
Blower case open. 3D semi-open impeller visible.

A combustion air blower of a sulfuric acid production plant, driven by electric motor and controlled by Inlet Guide Vane (IGV), intakes air at atmospheric conditions and delivers it at 1.4 bara discharge pressure; the requested air mass flow rate is about 200.000 kg/h while shaft power is about 2.6 MW. As shown in Figure 1, the compressor is single stage overhung impeller, composed of a welded-type 3D semi-open impeller (external diameter 1600 mm) having a connection ring at blades tip on inlet section, a short vaneless diffuser, and a welded-type volute with rectangular cross section.

During its lifetime, the end user experienced a progressive decrement of compressor performance, both in terms of delivered flow rate and efficiency, until he decided to refurbish it to recover its original performance. CST was involved in such activity by the service provider in charge of the combustion air blower maintenance.

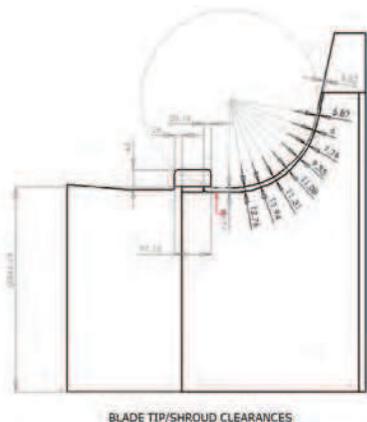
FIGURE 2
Impeller/shroud cross section with obtained impeller clearances.

A 3D laser scanning was performed to obtain compressor 3D model for investigation. As shown in Figure 2, high clearance was detected by the impeller scan. High gap, enhanced by erosion, between impeller blades tip and stator shroud was observed: its magnitude was found variable along the blade length from 3.5% to 8% of the impeller diameter, instead of the usual

expected range of 1-2%. Moreover, the gap between impeller blades ring and the relevant static slot was found quite large.

The possible presence of a labyrinth seal in the original compressor configuration was inferred, given the high gap found between impeller blades ring and the statoric slot. That seal could be gone loose by erosion or other occurrences during compressor operation. Unfortunately, no information confirming such assumption was found from available documents and drawings.

In order to restore a good compressor performance and to avoid a too long time for installation and consequent facility extended downtime, the following two-step solution in sequence was implemented, leveraging a deep theoretical CFD investigation:

- the insertion of a labyrinth seal into the static slot, corresponding to the impeller inlet ring;
- the welding of an overlay on the impeller blades tip, to get an evenly reduced gap with the statoric part.

the labyrinth seal into the static slot on the impeller inlet ring and a blade tip clearance reduction of about 50% with respect to the measured ones was investigated to find the final impeller configuration. The result was that, by the modifications introduced, an increase of +1% of the compressor efficiency and of +6% of delivered flow rate could be got, thus achieving a satisfactory recovery of the combustion air blower performance.

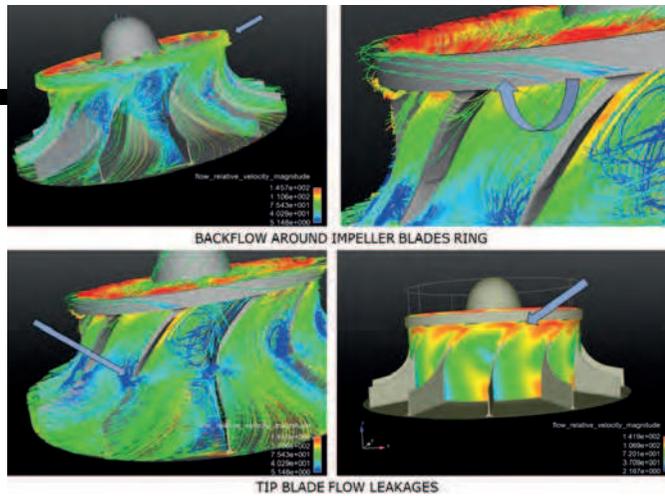
A CFD analysis was carried out to verify the fluid dynamic behavior of the damaged compressor, focusing on how much the compressor performance might be affected by the high tip gap clearance mentioned above. As shown in Figure 3, the presence of excessive clearance leads to a non-optimal flow-field. Two main fluid-dynamic phenomena, affecting negatively the optimal flow, were identified:

- a remarkable backflow around impeller blade ring
- a significant tip blade parasitic leakage flow (5.7% of impeller inlet flowrate)

These anomalies were considered as the main causes of the reduced stage efficiency and delivery flow rate.

FIGURE 3
CFD results: flow field visualization.

The CFD investigation campaign was carried out with the progressive implementation of that "two-step" sequence. The CFD investigation highlighted the importance of the reduction of the gap between the rotating and static components. The clearance between the impeller blades tip and the stator shroud came out to be of utmost importance for the performance recovery.

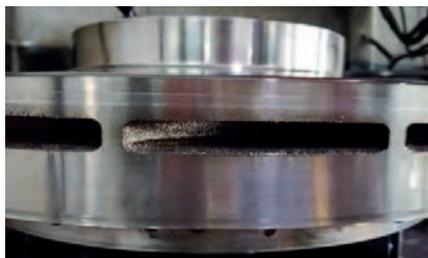
FIGURE 5 New compressor impeller during single-piece EDM manufacturing

ASTM A705 Gr.630 (17-4 PH) was used

instead of the original carbon steel, thus improving the resistance to corrosion and erosion and avoiding the occurrence of the experienced erosion damages. Moreover, the single-piece EDM manufacturing technology was adopted for the new impeller, obtaining a better blade profile with the following advantages:

- leading edge with a properly defined radius
- smoother flow path with a higher repetition accuracy among the various impeller channels
- avoidance of defects and obstructions due to the set up method adopted in the original impeller (rivets, see Figure 4)

New manufacturing drawings and specifications were produced, including balancing and overspeed test instructions. Figure 5 shows the new impeller during EDM manufacturing. The new impeller was mounted on the new rotor and installed in the existing compressor with full satisfaction of the customer. In fact, in addition to the erosion damages restoration, a higher performance of the compressor was achieved due to the higher efficiency of the refurbished stage (about +2%).

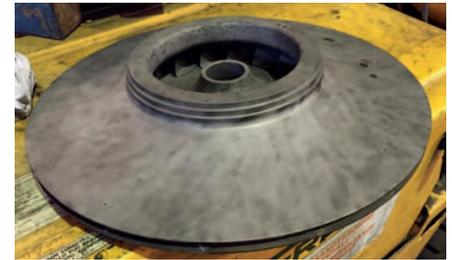
FIGURE 4
Original last compressor impeller (as found during standard overhaul).

During a routine overhaul of a 6 stages horizontally split air centrifugal compressor, the service company discovered the presence of strong erosion damages on the last impeller. The original closed impeller had been manufactured by an old manufacturing technology, using rivets to fix the blades to the disc and shroud (see Figure 4).

It was decided to substitute the impeller with a new one having the same meridional channel and blade camber profile to restore compressor performance. Since the original construction drawings and material specification were not available, some 3D scan of geometry measurements and chemical analysis were performed.
